## Moco-Moco Hydropower Plant: Site Assessment for Restoration

Prepared for  
**Government of Republic Guyana**

Supported by  
**Office of Climate Change (OCC), Guyana**  
**The Energy and Resources Institute (TERI), India**

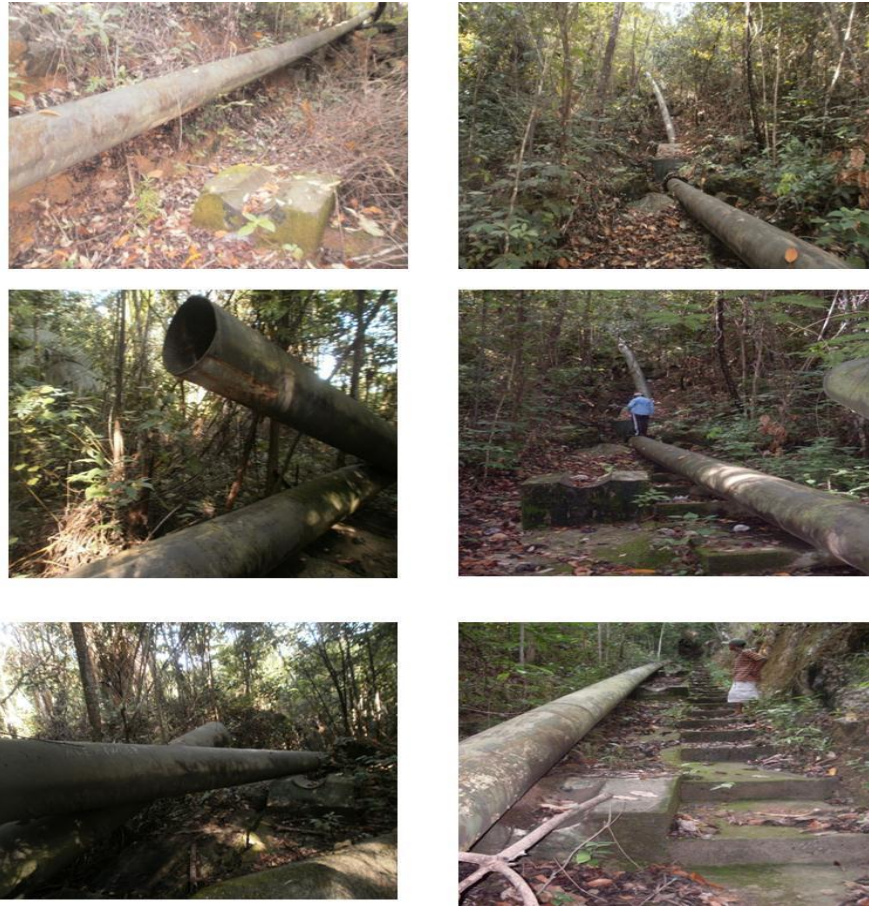
**Figure 2.1** Images of Damaged penstocks

The total length of the penstock is 577 meters, arranged along the slope from fore bay to the power house. The total elevation difference from fore bay to power house is 217.8 meters (difference in centre line of penstocks). The penstock has an internal diameter of 457.2mm with wall thickness of 9mm and 7mm. There are 8 thrust piers and 570 buttresses are arranged along the penstock. During the site visit it was found that the weir structure at the upper end of the Moco-Moco falls at the Moco-Moco River is in good shape. The land sliding mass is located between buttress 302 upstream of thrust pier - 2 and buttress 514 of downstream of thrust pier - 4, with a total length of about 215 meters, which accounts 37% of the total length of the pipe alignment is distributed. The major displacement of penstock starts from buttress -201 to 514. The penstock pipe line from buttress - 302 to 514 got displaced and deformed. The penstock between the thrust pier - 3 and thrust pier - 5 got bent and offset from the buttress with maximum displacement of about 4 to 6 meters from the original alignment. The pictures of the existing penstock are shown in Figure 2.1.

1. For restoration of penstock, geotechnical analysis is required to identify zones at risk to avoid landslide in future.
2. During the site visit it was observed that, small part of the penstock length is completely damaged, while most of the penstock length is displaced and deformed. It was estimated that, 75% length of the penstock pipe line is in good conditions 15% of penstock pipe line length is displaced and deformed around 10% length of penstock line need to be replaced with new pipeline. However, it is recommended to replace the entire penstock in order to have uniform design/ material as the cost of penstock is not significant in the total cost of replacement.

3. To avoid future landslides, the slope bordering the pipe line alignment must be cleared. It is recommended to provide rock anchors in rocky slope area.

4. Proper drainage system must be designed along the penstock line to divert rain water.
5. The penstock supporting structure should be designed properly by providing clamp with cushion (Teflon) pad, to allow free movement of the pipe in longitudinal direction.

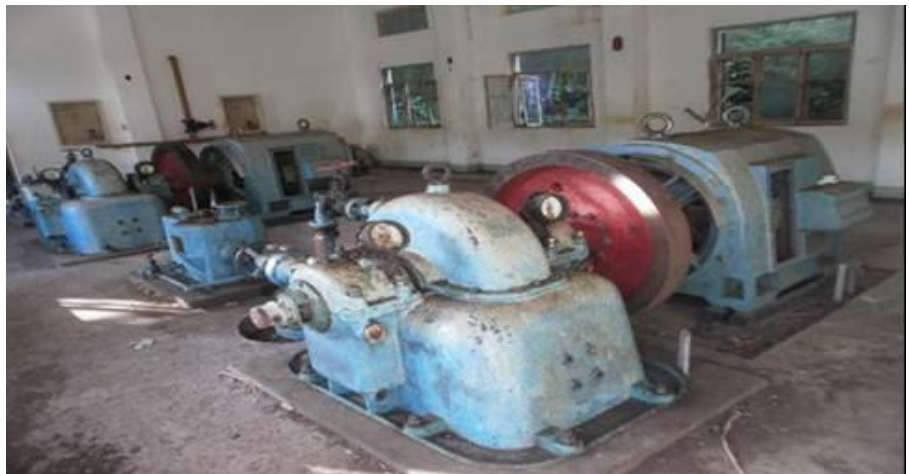
**Figure 2.2** Damaged turbines and Generators

Power house has two horizontal Pelton turbines directly coupled to synchronous generators complete with auxiliary equipment and a separate electrical panel room. The pictures of turbine hall and electrical room are given Figure 2.2.

Internal structural parts of turbines and turbine speed governor systems are damaged condition. There is no water flow meter at the turbine inlet, installed inlet pressure gauges are damaged conditions. Turbine runner wheel should be inspected for traces of abrasion.

1. Power house equipment is tailor-made based on the site requirement. Repair of turbine, generator, governor system and switch board (including electric cables and panel) is not economical, original supplier need to be contacted for the repair, but it is highly unlikely that they will be able to provide spares as the plant is more than 10 years old.
2. It is recommended to replace all power house equipment with turbines, generators, governor, switchgear, control, protection, metering and auxiliary equipment complete with new equipment and latest control/protection/monitoring system with SCADA.
3. Discussions with the suppliers revealed that the cost of penstock restoration estimation will not be possible at this stage. It need to be defined based on the selection of new equipment.

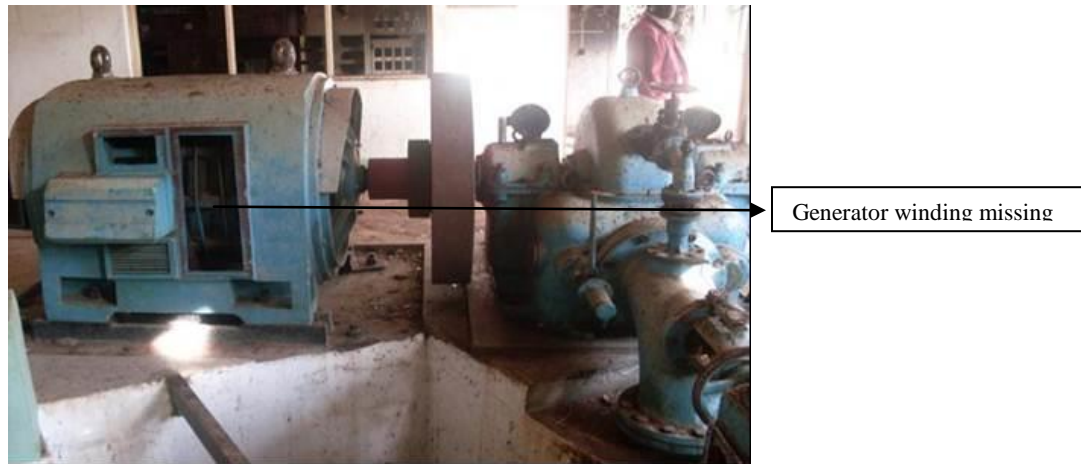
**Figure 2.3** Damaged synchronous generator

The copper winding coil of generators is missing generator is in completely damaged condition. The entire turbine-generator units of both the units need to be replaced. The damaged synchronous generator is shown in figure – 2.3.

It is opined that repair of existing generator will not be economical. All the control and protection systems of turbine-generator systems are in breakdown condition and require replacement.

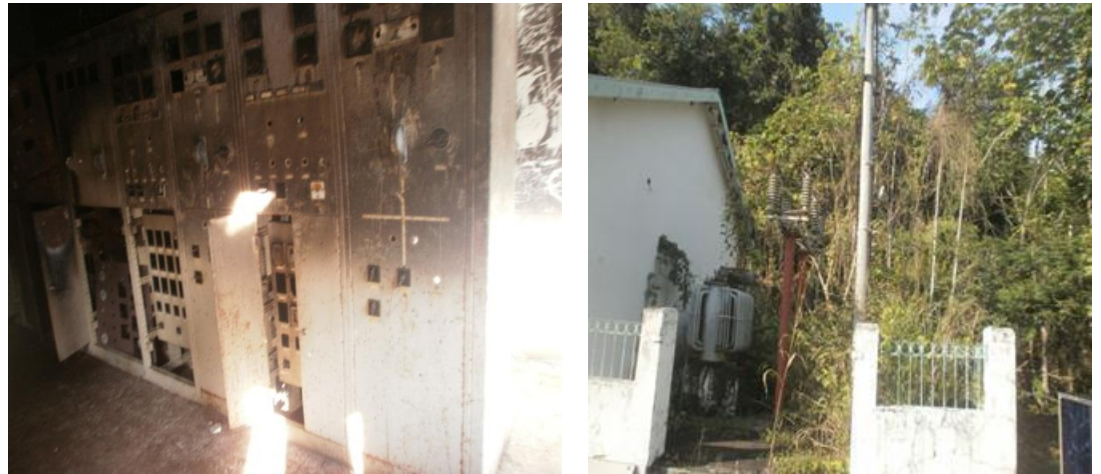
**Figure 2.4** Burnt electrical switch board and damaged transformer

In the Electrical System room, it is observed that all the switchgear, control, protection, metering and auxiliary systems are in damaged condition. It was reported that after the incidence of landslide, transmission line was being charged by supplying power from diesel generator. During this process, power was fed from Letham diesel generator station to the transmission line and as there was no isolation/protection between electrical system of hydro-power station and transformer, fire resulting from a fault in the system, destroyed the entire switch gear panel including transformer. The picture of destroyed electrical switchgear panel and transformer is given in Figure – 2.4.

From the site visit it is clear that entire electrical switchgear, electrical control, protection, metering and auxiliary systems need to be replaced with new systems.
